Five case studies demonstrating Negative Pressure Wound Therapy using the gauze-based dressing technique

Glenn Smith RN (MH) BN (Hons), Tissue Viability Nurse, Isle of Wight Primary Care Trust

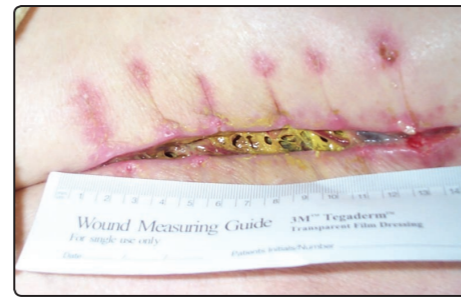
Pre-NPWT

- Aim and Objectives:**
- Debridement of a sloughy wound
 - To contain exudate to protect the peri-wound area from further breakdown
 - To allow patient to return home with treatment continuing
 - Reduction / elimination of infection
- Type of Drain Used:**
- Flat drain
- Pressure Settings:**
- 60mmHg initially, increased to 80mmHg after first dressing change
- Clinical Outcome:**
- No attempt was made to debride the wound prior to the application of NPWT - slough content disappeared within the first 7 days
 - Patient discharged home after 7 days and treatment continued with District Nurse's and Tissue Viability Nurse's supervision
 - Amount of exudate reduced to negligible levels

Case Study 5: A 76 year old lady presented with a non-healing mid-spinal wound after back surgery. The wound had become infected and the patient had been readmitted to hospital and given antibiotics. The patient appeared to be malnourished both as a result of pain relief causing a poor appetite, and the antibiotics inducing diarrhoea thus compounding matters through malabsorption. On removal of the sutures the wound dehiscd and it was evident that the wound was in a chronic state.

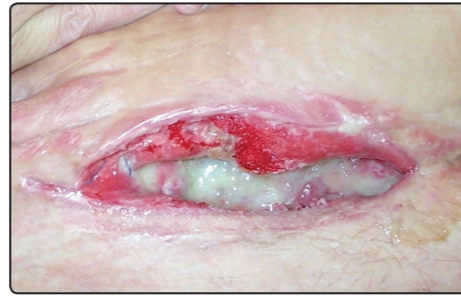
Pre-NPWT

- Aim and Objectives:**
- Debridement of slough from wound base
 - To contain exudate and protect peri-ulcer area
 - To allow patient to be discharged home as soon as possible

- Clinical Outcome:**
- Patient discharged home into care of District Nurse's and Tissue Viability Nurse's supervision after 3 days of commencing treatment
 - Exudate levels reduced rapidly and wound base cleared of slough with the first 7-10 days without any alternative debridement treatment being used
 - Wound improved until it was too small to take a drain and conventional dressings were used

Case Study 1: A 42 year old female had had an inguinal hernia repair. The wound was closed using metal sutures but the patient had an allergic reaction to them which consequently lead to her body rejecting the metal sutures and setting up an inflammatory reaction. This led to her surgical wound dehiscing and becoming infected, malodorous and sloughy.

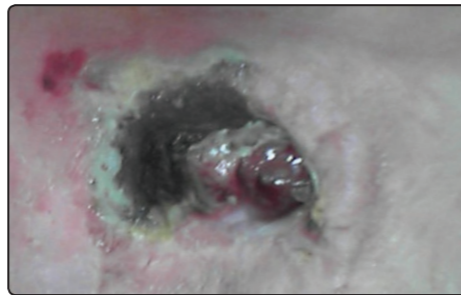
Pre-NPWT

- Aim and Objectives:**
- Debridement of wound, 75% of which necrotic tissue
 - To prevent contamination of wound with faecal material
 - To accelerate closure of wound

- Clinical Outcome:**
- Wound completely debrided by NPWT - no attempt to debride the wound was made prior to application of NPWT
 - Granulation tissue present although slow due to severity of chronic renal failure and total paraplegia meant that patient could not totally remove pressure from that area
 - Patient not totally compliant as turned off pump when receiving dialysis
 - Treatment discontinued due to the above difficulties

Case Study 2: A 65 year old male patient presented with a sacral ulcer. This was complicated due to immobility as the patient was paraplegic and had lost all feeling below his waist so did not receive any sort of feedback that he needed to

reposition himself. The patient was also doubly incontinent, and whilst his urinary incontinence was managed by a permanent, long-term catheter, the matter of the faecal incontinence was still to be addressed resulting in regular recontamination of the wound by faeces. The patient was also diabetic and in chronic renal failure, necessitating dialysis three times a week. These combined factors made the wound even more difficult to heal.

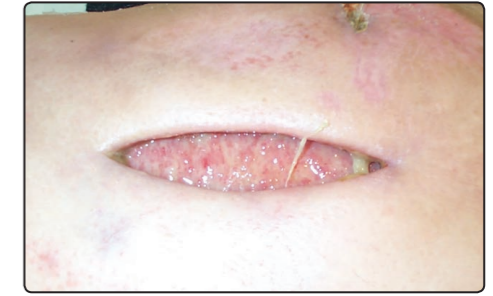
Pre-NPWT

- Aim and Objectives:**
- Reduce exudate / decrease infection
 - Prevent further hospital admissions
 - Increase speed of granulation tissue
 - Allow patient more independence

- Clinical Outcome:**
- Dressing changes 3 x weekly initially, but reduced to 2 x weekly after 3 weeks
 - Patient discharged from hospital as soon as therapy commenced - Tissue Viability Nurse supported Community Nurses with dressing changes
 - Patient was independent and spent long periods using the power unit on battery power
 - Wound quickly became free from infection, exudate levels negligible which allowed patient to have a successful skin graft

Case Study 3: A 48 year old male patient presented with a post-operative dehiscence of a hip wound after a washout of the wound. The patient had had a hip replacement operation and had repeated infections which necessitated several readmissions and washouts of the wound area and hip cavity. The wound was clean but producing high levels of exudate, necessitating daily dressing changes. The wound was evidently becoming chronic and the granulation tissue appeared static and unhealing.

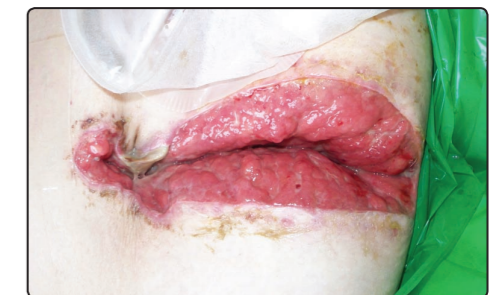
Pre-NPWT

- Aim and Objectives:**
- To prevent risk of infection
 - To promote speed of granulation
 - To allow patient to be discharged back to nursing home

- Clinical Outcome:**
- NPWT applied in hospital but patient discharged to nursing home with support of Tissue Viability Nurse
 - Dressing changes reduced to 2 x weekly after first 3 weeks of NPWT
 - Wound quickly contracted beyond the point that NPWT dressing was useful: on removal wound measured 14cm long x 5cm wide x 1cm deep

Case Study 4: A 64 year old female patient had a ileostomy formation, after which her abdominal wound dehiscd. The wound was clean but extensive, extending down through fascia of the patient's abdomen to the abdominal wall. The patient had a higher than average BMI and as a result this contributed to putting stress on the sutures and the wound split apart after the sutures were removed. There were high levels of exudate, necessitating dressing changes more than once a day. Wound measured 30cm long x 10cm wide x 6-8cm deep.
