The use of negative pressure wound treatment as an aid in plastic surgery on a traumatised foot

Dr. G. Marangi, Dr. S.Tenna, Prof. Persichetti, Reconstructive Plastic Surgery, Rome Biomedical Campus, Italy

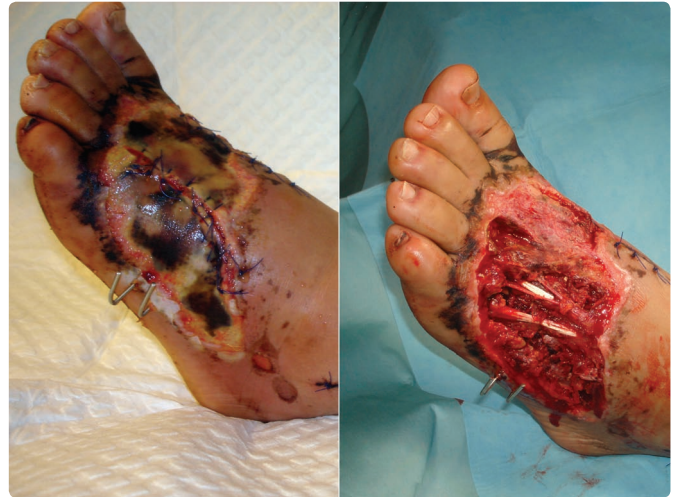
Initial appearance of the wound, before and after curettage and escharectomy

On 4th March curettage of the wound and tangential escharectomy of the back of the left foot were performed. After the operation, there was a loss of tissue measuring approximately 15cm x 6cm maximum diameter, corresponding to the distal portion of the left foot, with no involvement of the toes, with poorly defined irregular edges and clear limits. The

extensor tendon of the III, IV and V radius was partially exposed. The surrounding skin was erythematous and oedematous.

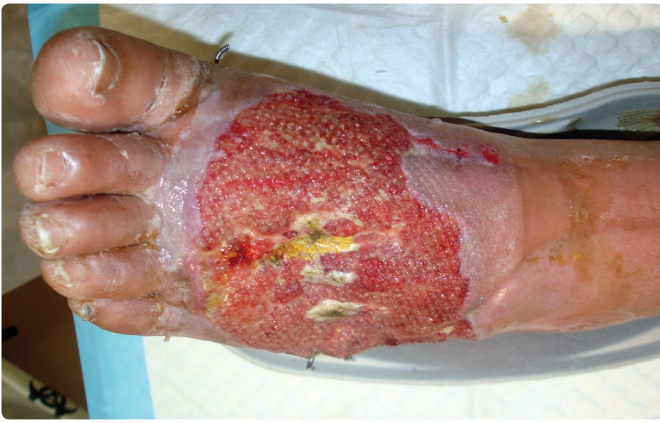
Appearance of the wound on 2nd April

The VENTURI™ negative pressure system allowed good tissue granulation to be obtained in the first phase, after surgical debridement, with progressive covering of the exposed tendinous structures, promoting the preparation of the wound bed for application of the covering dermal epidermal graft.

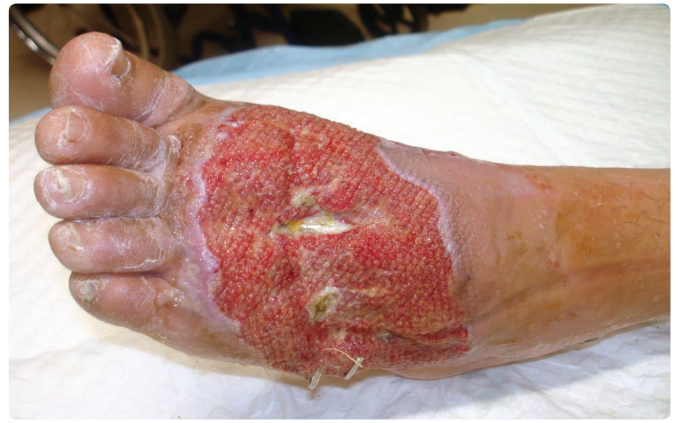
Appearance of the wound on 7th April

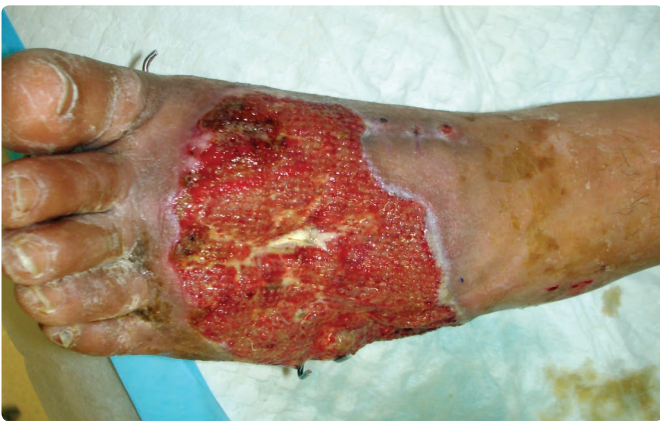
Appearance of the wound on 16th April

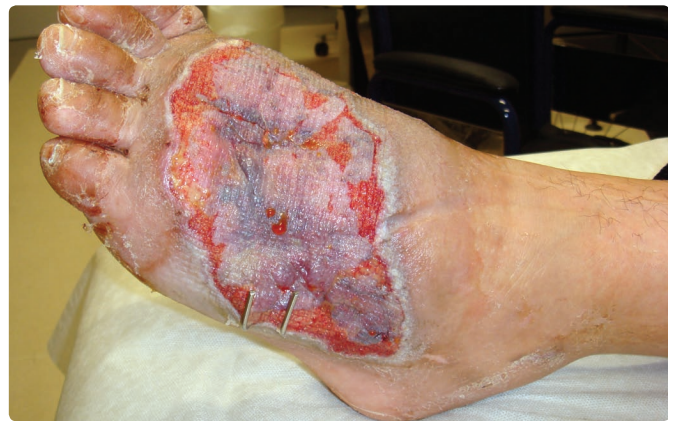
Appearance of the wound on 2nd May

The graft was again treated with the application of the VENTURI™ system, which remained in place for a further 5 days.

The VENTURI™ also allowed the graft to attach quickly, and faster recovery of the lost tissue.
